First Five-Year Review Report

Carson River Mercury Site

Dayton and Silver City, Nevada

September 2003

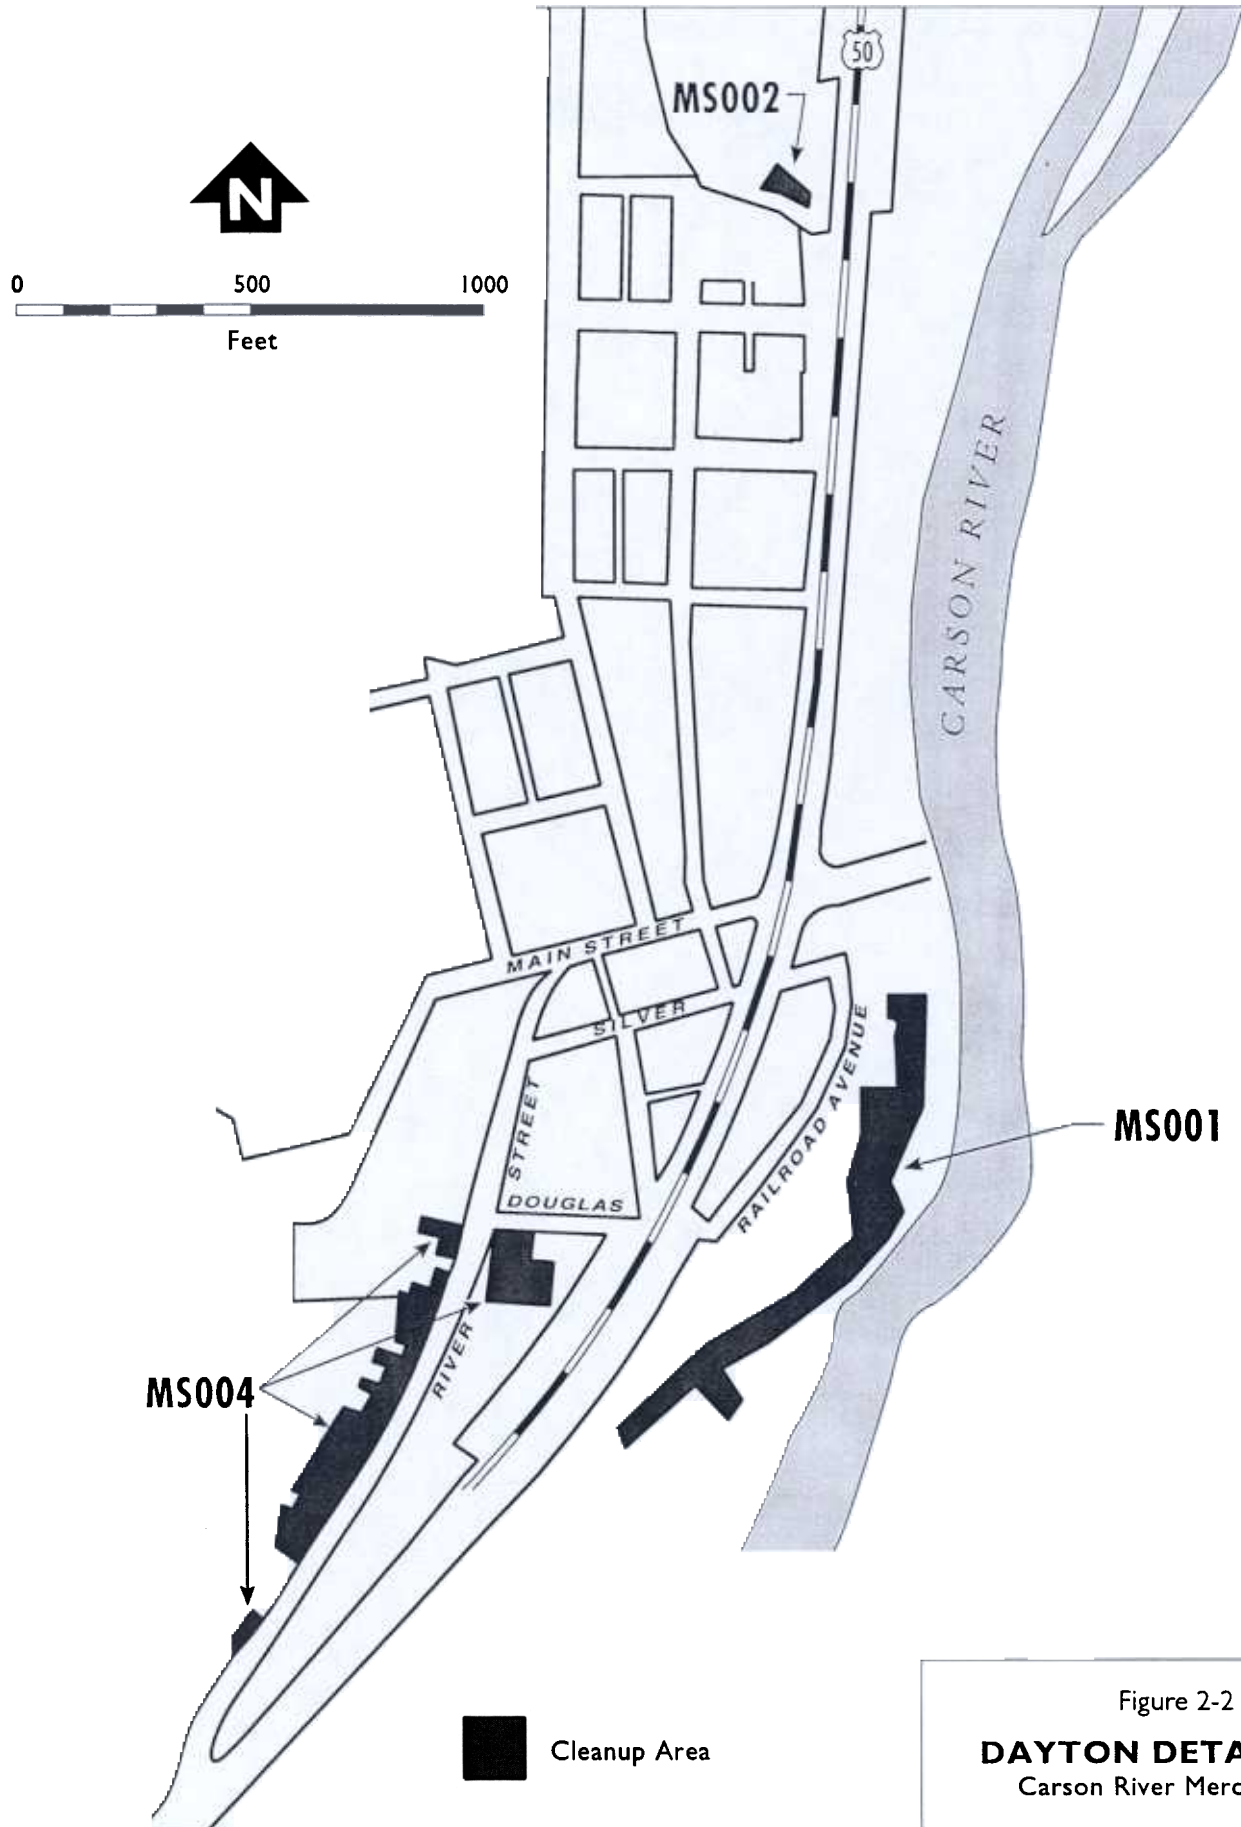
Figure 2-2

The four areas of concern where remediation occurred are residential properties designated MS001, MS002, MS004, and MS030. Their locations, shown in Figures 2-1 through 2-3, are as follows:

DAYTON DETAIL MAP
Carson River Mercury Site

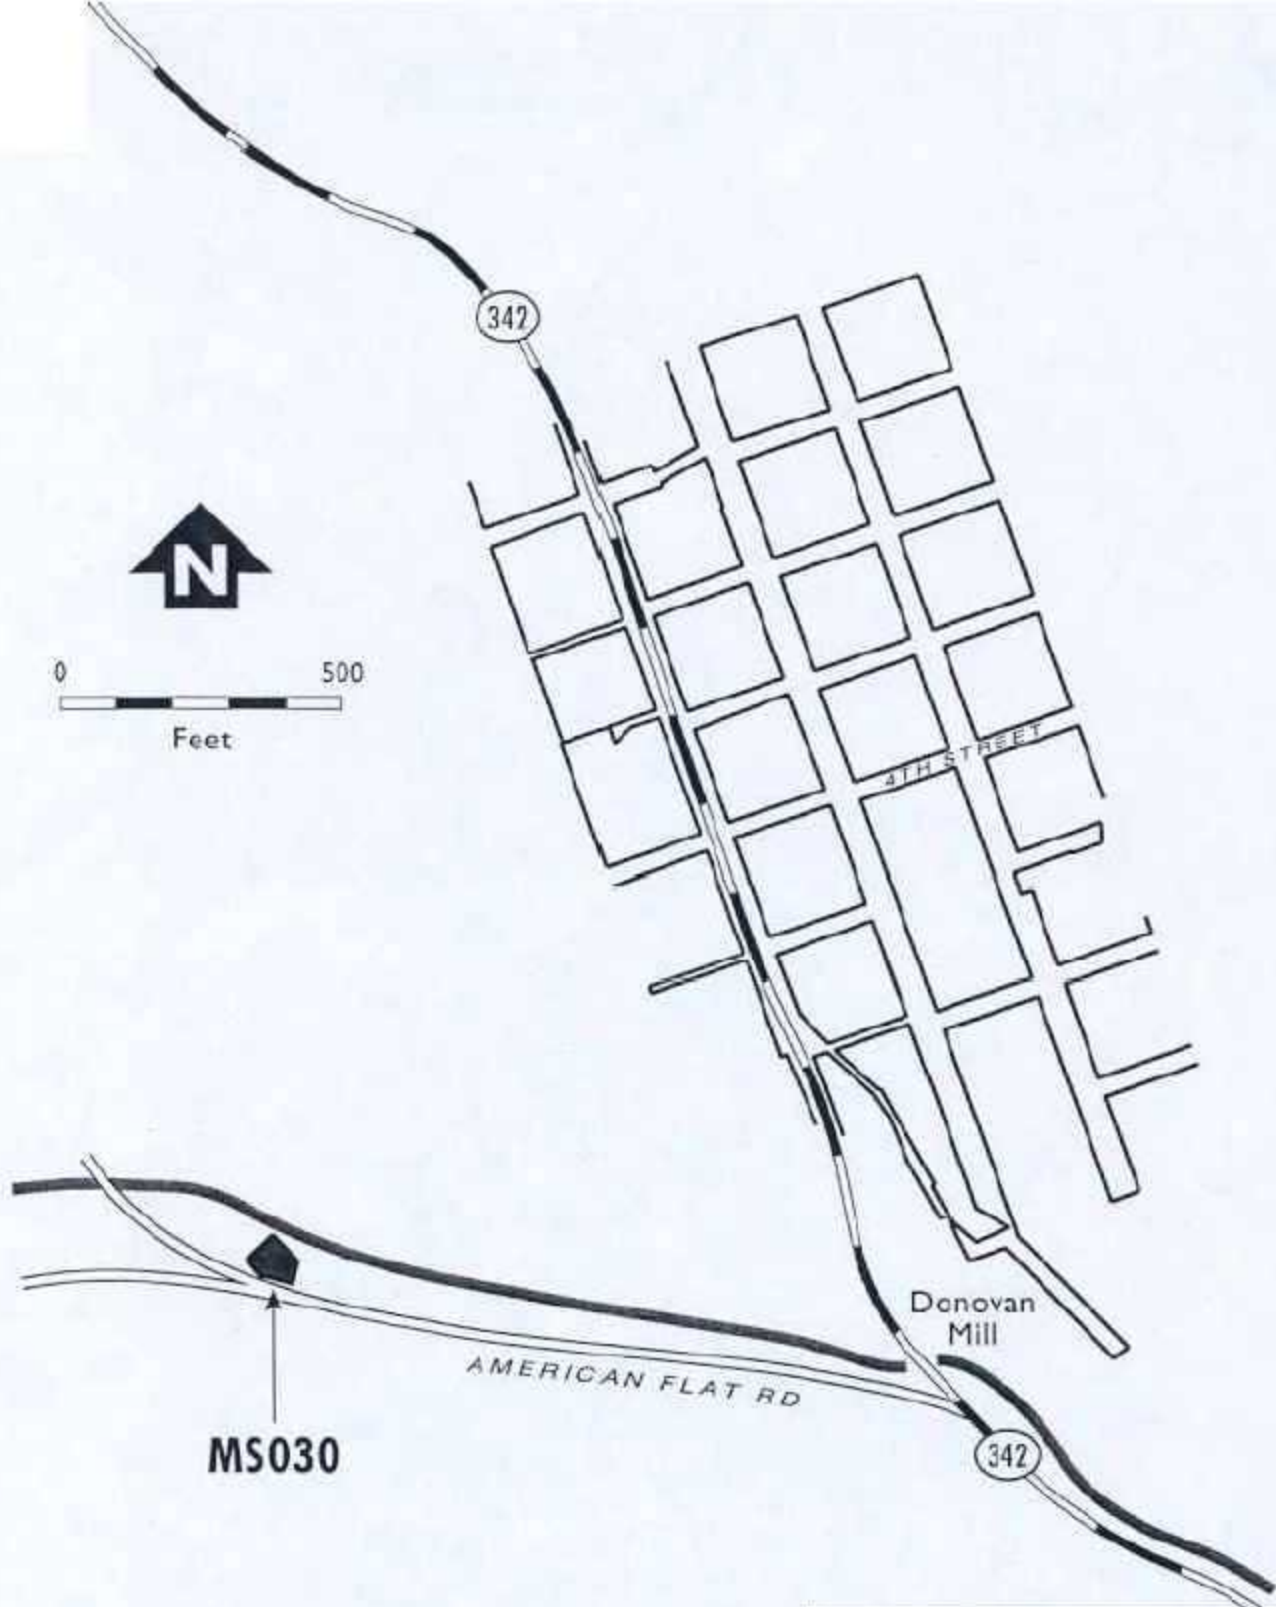
Figure 2-3

Cleanup Area

SILVER CITY DETAIL MAP
Carson River Mercury Site

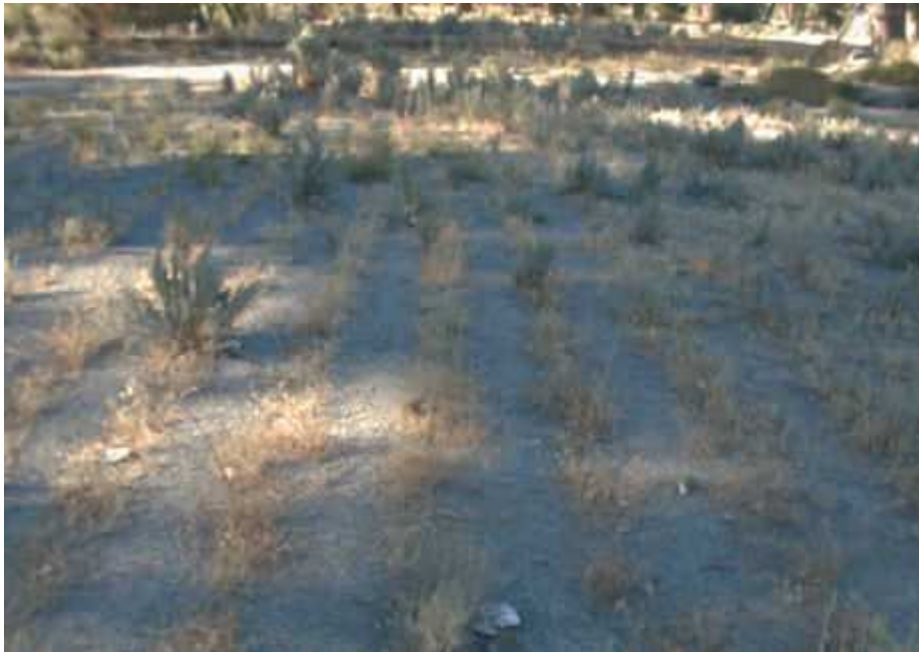
C MS001 South and North. The remediated area appeared largely as it did in 1999 at the completion of the remedial action. No recent excavation activity was apparent in the remediated areas, and the fill material was intact and in place. The vegetative cover was uneven and varied in the extent of cover. In much of the area, vegetation was growing in parallel rows, with the areas between rows largely bare (see photo). This pattern may result from vegetation growing in remediated areas where the soil was ripped or loosened, and not in other areas due to compaction. The vegetation consisted of a mix of sagebrush and grasses.

Photo #1: remediated area at MS001, showing pattern of re-vegetation

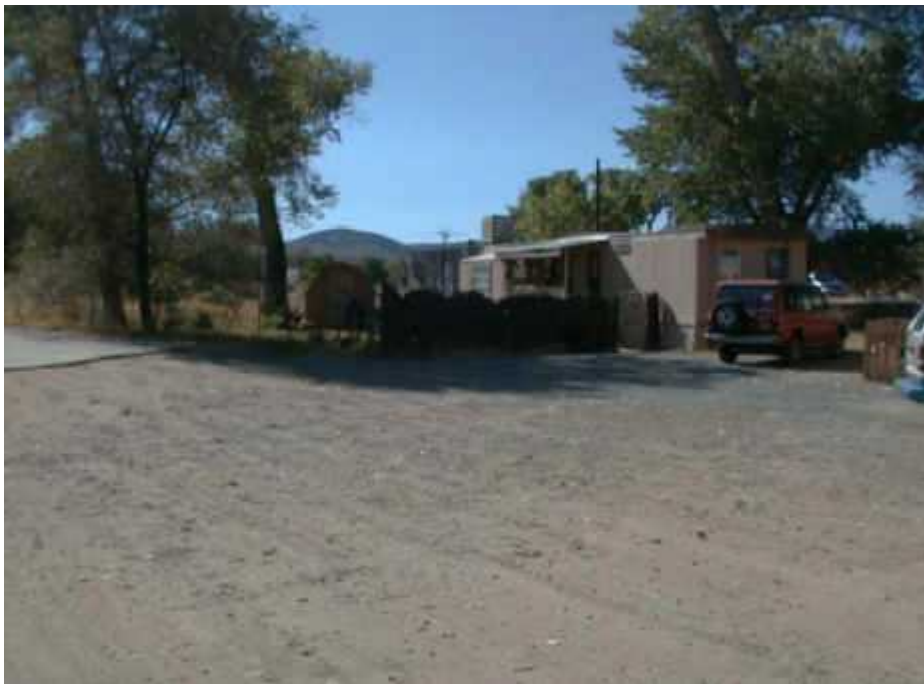
C MS002. The remediated area appeared largely as it did in December 1999 at the completion of the remedial action. No excavation activity was apparent in the remediated area, and the fill material was intact and in place.

Photo #2: remediated area at MS002

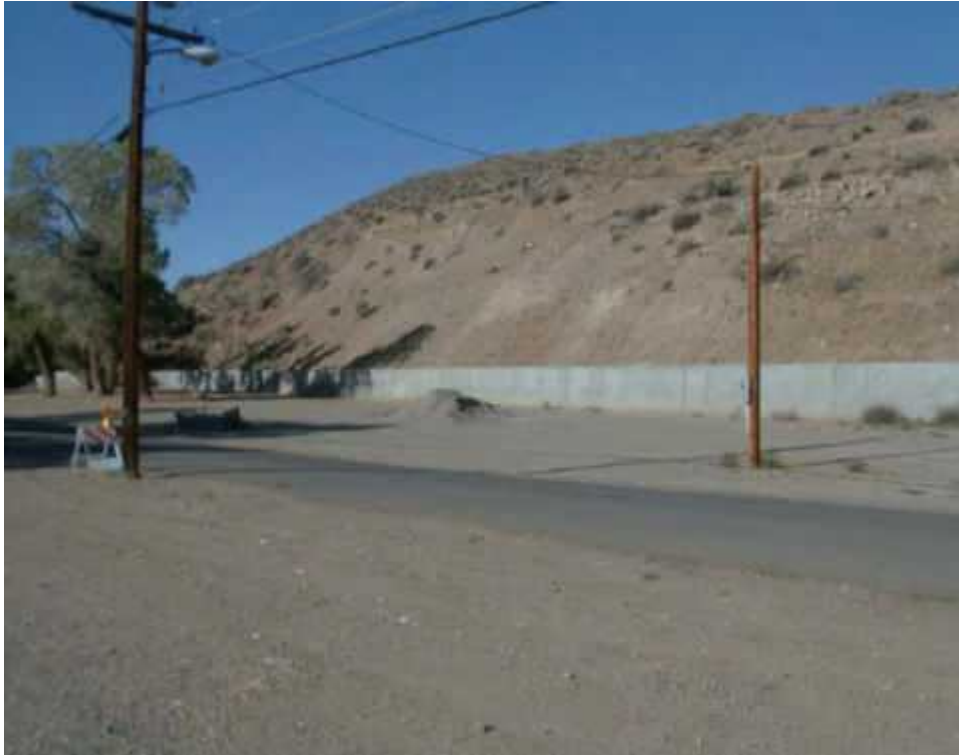
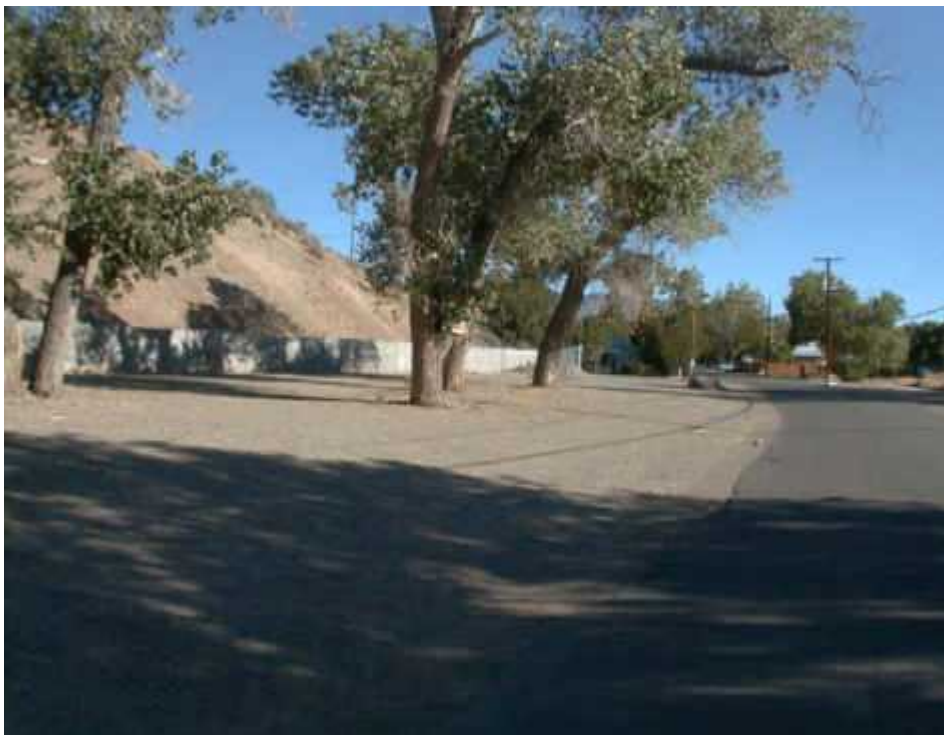
C MS004. The remediated area appeared largely as it did in December 1999 at the completion of the remedial action. No excavation activity was apparent in the remediated areas, the fill material was intact and in place, the drainage system appeared intact and functional, and the soil retaining wall (constructed by the property owner) appeared intact and in good condition. The hillside to the west of the remediated area appeared stable. A minor amount of soil and rock had sloughed off the hillside and been deposited behind the wall, as designed.

Photos #3-4: remediated area at MS004, showing hillside, soil barrier wall, remediated area adjacent to wall
